# Identification of sensitive feature in the stray magnetic field to detect rotor short-circuit fault in synchronous generators

**Abstract**—This paper presents an application of the external magnetic field measured in the vicinity of a synchronous generator in a hydroelectric powerplant for the detection of a rotor short circuit fault. The measurement of the external magnetic field was performed using a flux sensor and the analysis of the signal is done in a quantitative and qualitative way by considering the spectral evolution of the signal but also its temporal variation. The presented results are obtained analyzing several operating conditions of a 55 MW generator in healthy and fault case. We notice the interest of using the reduced values in percentage to better compare the different state of the machines. A vibration study is also presented at the end of the paper to complete the analysis.

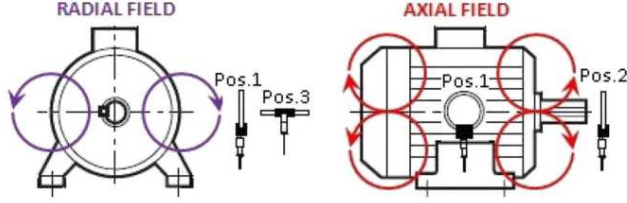
is rather sensitive to the currents in the stator and rotor end windings. The radial magnetic field is in a plane perpendicular to the longitudinal axis and is the image of the air gap induction which is attenuated by the stator laminations but also by the external frame of the machine. The radial magnetic field has 2 components, a normal direction, and a tangential direction. Therefore, the external magnetic field has three components that can be distinguished experimentally by an appropriate choice of a flux sensor position as shown in Fig. 1.

Fig. 1. Radial and axial flux decomposition

In this study, we consider only the signal from the TAN axis, equivalent to position pos.3 in Fig. 1. In this position, the sensor is supposed to be insensitive to the axial field generated by the current flowing through the end windings of the machines. The obtained signal is an image of the airgap flux

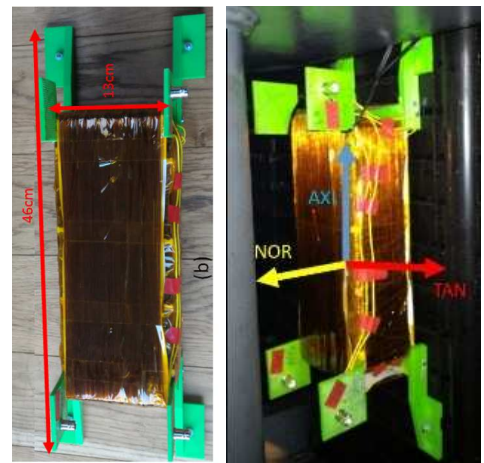
The used sensor is a tri-axial wound flux sensor (Fig. 3) specially sized to be adapted for high power machines. It is composed of 3 windings of axis NOR, AXI, and TAN. It has 4 tabs with magnets so that it can be easily installed against the external frame of the machines. This sensor has the advantage to be directly connected to a data acquisition system without any filter or amplifier.

Fig. 3. The tri-axial stray flux sensor

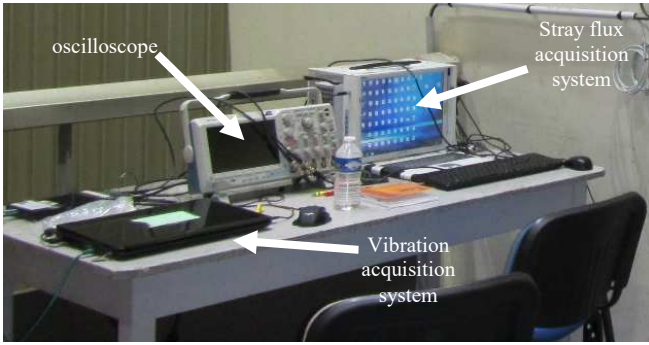
For both investigated machines, 15 operating points are be considered: three points for the active power (0%, 50%, 100% of  $P_n$ ), combined with five points for the reactive power (-100%, -50%, 0%, 50%, 100% of  $Q_n$ ). For each operating point, we pick up the flux sensor signal and the accelerometer signal on two acquisition systems: A pulse system from Bruel & Kjaer that compute directly the FFT of the signals and a PXI data acquisition system with LabVIEW that records the signal. The acquisition duration is 5s with a sampling frequency at 20 khz. Therefore, the recorded length is 10000 points. Fig. 4 shows a picture of the whole acquisition system.

Fig. 4. Data acquisition system

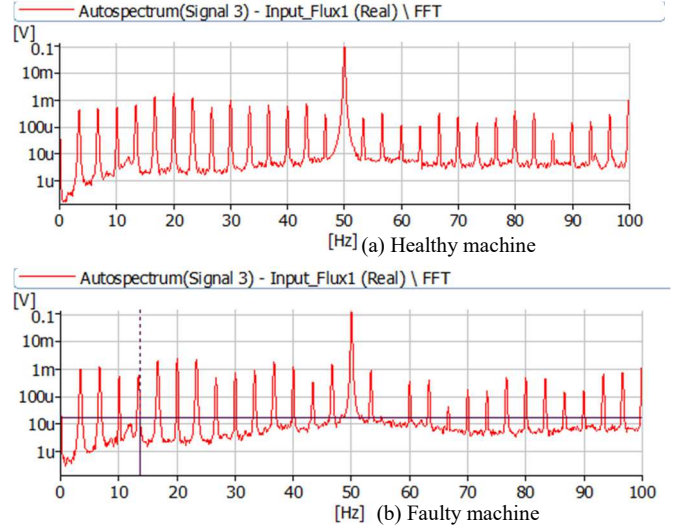
Fig. 5 shows the spectra over the 0-100 Hz frequency range of the signal measured by the flux sensors at the operating point  $P=100\%$ ,  $Q=100\%$  for the healthy and the faulty machine. We can clearly see the fundamental at 50 Hz, and the presence of spectral lines every 3.33 Hz, corresponding to the rotation frequency of the machine. Therefore, there are 15 lines between 0 and 50Hz, and 15 others between 50 Hz and 100 Hz. All these spectral lines are related to sensitive frequencies given by (1) and (2) relative to the rotor faults and dynamic eccentricity. The lines at 3.33 Hz, 6.66 Hz, and 10 Hz ( $kr=0$ ,  $h=1,2,3$  in (1)) can be accounted for the rotor short-circuit fault, and the lines at 47.66 Hz, 43.33 Hz, and 40 Hz ( $h=-1, -2, -3$  in (3)) to eccentricity. As a first observation, we can see that the sensitive spectral lines appear even for the healthy machine and the difference between the healthy and the faulty machine is quite small. In real machines, there is always minor imperfection due to tolerances in the manufacturing process. Therefore, a pure healthy machine is not a reality.

Fig. 5. Stray flux spectrum for the healthy (a), and the faulty machine (b)

However, further information can be highlighted if we compare the first rank of the rotor fault-sensitive components at 3.33 Hz, ( $kr=0$ ,  $h=1$ , in (1)) and the second rank at 6.66 Hz

( $kr=0$ ,  $h=2$ , in (1)). Table II and Table III gives the magnitudes of the 3,33 Hz and the 6,66 Hz spectral lines for the 15 operating points for the Healthy and for the faulty machine and the variation direction between both frequencies. For the healthy machine, we can see that the variation is mainly positive (14  $\nearrow$  and 1  $\searrow$ ) and for the faulty machine, the variation is mainly negative (11  $\searrow$  and 4  $\nearrow$ ). This is a logical result. Indeed, when the machine has a short circuit fault, the main sensitive spectral line at 3.33 Hz characteristic of the fault (rank  $kr=0$ ,  $h=1$ , in (1)) is higher than the second rank at 6.66 Hz ( $kr=0$ ,  $h=2$ , in (1)), so we have a downward trend. On the other hand, in absence of fault, the main sensitive line at 3.33 Hz is lower than the second one 6.66 Hz. The main reason of this property is that the main rank harmonic has generally a higher magnitude than the second rank one.

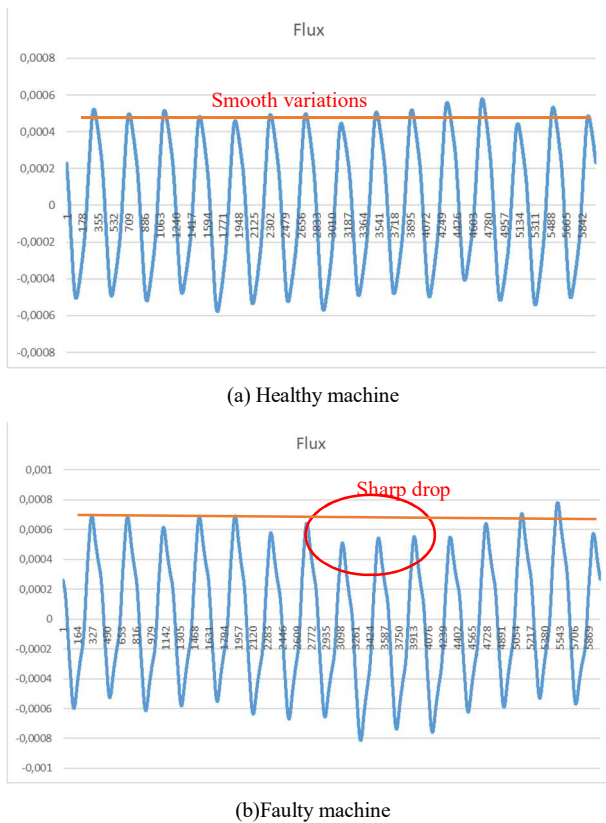
Fig. 6 shows the linkage flux of the sensor for one revolution of the healthy and faulty machines. The flux is obtained by integration of the voltage signal delivered by the flux sensor. In both flux signal, one can find 15 positive poles (north pole) and 15 negative poles (south pole), but it can be observed that the flux magnitude are different for each pole-pass even for the healthy machine, which means that this machine is probably not perfectly health. This is in accordance with section IV.A about the frequency domain qualitative analysis where the presence of eccentricity was also mentioned. Actually, both eccentricity and rotor fault may cause a change in the magnetic effect of one rotor pole, but it can be expected that the eccentricity produces a smooth change of the flux magnitude over one rotation whereas shorted turns produce a sharp drop of the linkage flux of the sensor as shown in [17]. In addition to eccentricity and rotor shorted turn, another phenomenon may cause flux magnitude variations. Actually, due to manufacturing a positioning imperfection of the rotor poles, the airgap between the rotor pole and stator may be not perfectly constant which can make some magnitude variation of the airgap flux density and also magnitude variation of the sensor flux linkage.

In Fig. 6 it can be seen that the flux magnitude presents regular smooth change that may be caused by the eccentricity or manufacturing tolerances for the healthy machine (Fig. 7.a) whereas a sharp drop appears for the machine with rotor shorted turns (Fig. 6.b). Therefore, time domain analysis can be complementary to the frequency domain analysis to detect

Fig. 6. Time domain signal, healthy machine (a), faulty machine (b)

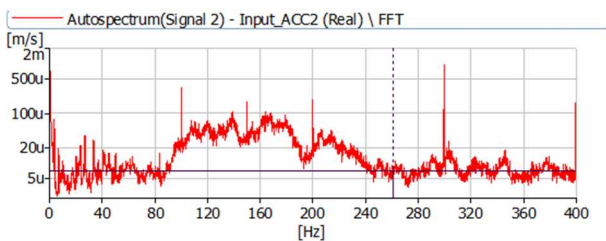
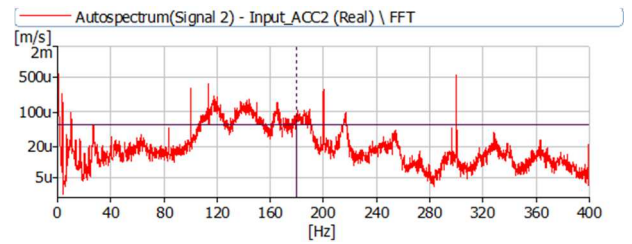
The vibratory analysis is not at the heart of the paper, but in this section, we can try to evaluate the consequence of rotor shorted turns on the mechanical behaviour of the machine. The accelerometer is placed on the external frame of the machine, close to the flux sensor. Fig 7 shows the spectrum of vibration (speed information) for both machines in a 0-400 Hz frequency range. Firstly, it can be observed that the spectra are roughly similar. The spectral lines at 100 Hz, 200 Hz, and 300 Hz which originate from electrical excitation of the stator frame clearly appear. They are due to radial forces between the stator and the rotor. In a very low part of the spectrum, the main finding concerns the spectral line at 3.33 Hz that goes from  $78\mu\text{m/s}$  for the healthy machine up to  $366\mu\text{m/s}$  for the faulty machine, for an operating condition with  $P=100\%$ ,  $Q=100\%$ . A deeper analysis should be taken with care because of the complex mechanical structure of the machine.

(a) Healthy machine  $78\mu\text{m/s}$  à 3.33 Hz

(b) Faulty machine,  $366\mu\text{m/s}$  à 3.33 Hz

Fig. 7. Vibratory spectrum
